## SERVICE BULLETIN REVISION TRANSMITTAL SHEET

TITLE: WINGS - GENERAL - ONE TIME INSPECTION OF TAPERLOK BOLT AT

WING TO FUSELAGE JUNCTION.

This page transmits Revision No.03 of Service Bulletin No.A320-57-1140

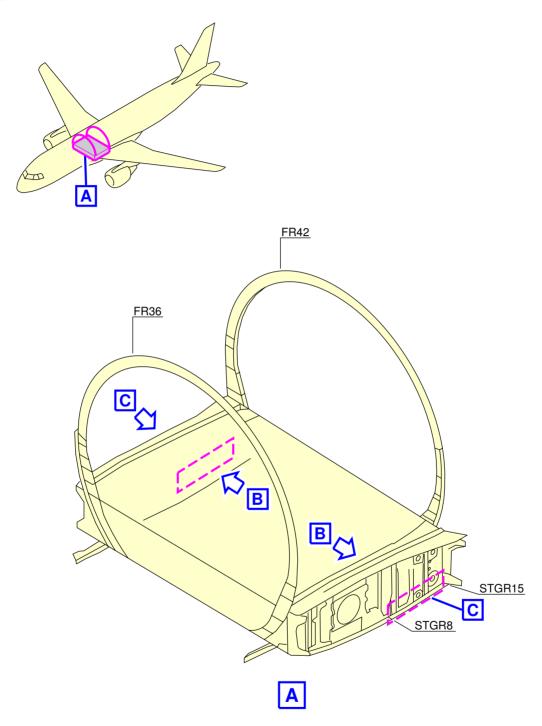
Figure A-FBAAA - Sheet 01 Inspection of the Fasteners

During installation of the wing to the center wing box in the AIRBUS A320 family Final Assembly Line (FAL), some taperloks used in the wing to fuselage junction at RIB 1, were found to be non-compliant with the specification.

- replace the nut by self-locking nut with appropriate washer.
- replace the damaged taperlok with a new taperlok at next nominal diameter with self-locking nut.

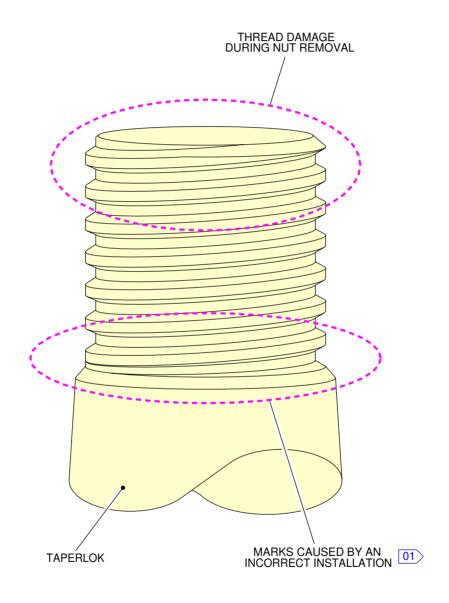
### THREAD DAMAGE

01 FOR MORE INFORMATION OF THE CRITERION MARKS REFER TO THE BOOKLET 06-0009 N\_SB\_571140\_5\_BCAA\_01\_00

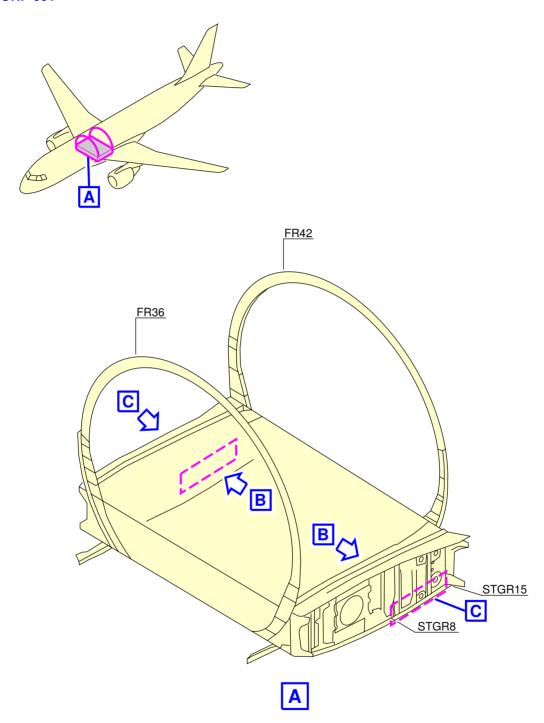
Figure A-FCEAA - Sheet 01
Inspection of the Fasteners for the ADDITIONAL WORK

The ADDITIONAL WORK consists in inspecting new fasteners located in the center and outer wing box in the Rib1 area.
